MONTANA HISTORICAL AND ARCHITECTURAL INVENTORY

Legal Description: Block 1, Lot 1, Roundup First Addition

Address: 621 Fourth Street East

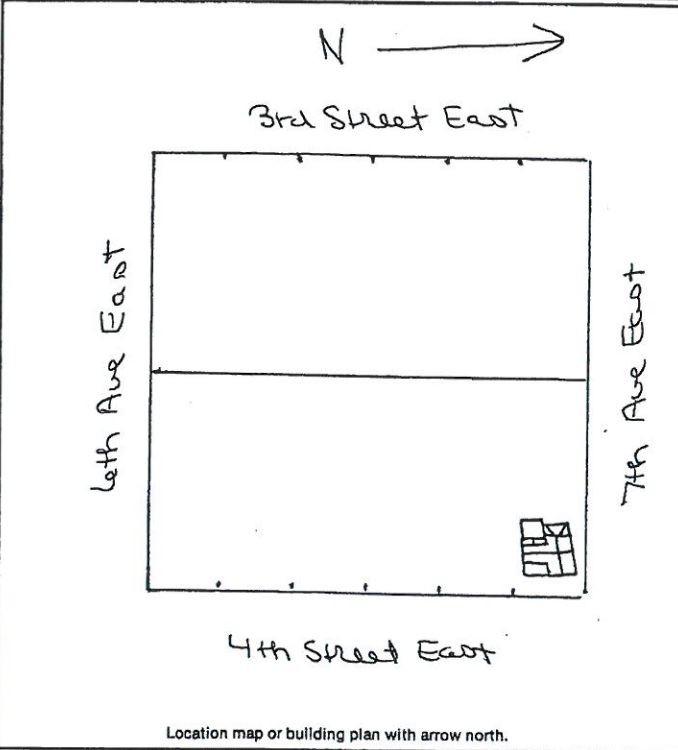
Roll # A13 Frame # 18

This square, one and one-half story, wood-frame residence has an intersecting gable roof, an end gable-roof dormer with pent roof gable return, a side shed roof dormer, one hip roof addition, one shed roof addition and a shed roof screen enclosed porch. Other features include an interior brick chimney, enclosed eaves with gable corner decorative wood cuts, 1/1 double-hung windows, cement foundation. Modern materials include asphalt roofing, steel siding, front porch screens and plastic sheeting, various aluminum frame windows and storm windows.

This house is at the east edge of town across the street from the cement mixing plant. This house has lost integrity of design due to the assorted additions. It has lost integrity of materials due to steel siding and asphalt roofing.
