MONTANA HISTORICAL AND ARCHITECTURAL INVENTORY

Historic Name: <u>La Pierre's filling station</u> Common Name: _____ Date of Construction: <u>before 1920</u> <input type="checkbox"/> estimated <input checked="" type="checkbox"/> documented Architect: _____ Builder: _____ Original Owner: <u>Candy and ice cream store</u> Original Use: <u>Saw repair shop</u> Present Use: _____ Research Sources: <input type="checkbox"/> abstract of title <input type="checkbox"/> city directories <input type="checkbox"/> plat records/maps <input type="checkbox"/> sewer/water permits <input checked="" type="checkbox"/> tax cards <input type="checkbox"/> obituaries <input type="checkbox"/> building permit <input type="checkbox"/> biographies <input checked="" type="checkbox"/> Sanborn maps — dates: <u>1920; before 1920</u> Bibliography: <u>Interview: Bob Waltz 7/14/83</u> <u>Fred Tressl 8/22/83</u> <u>Chain of Ownership cards, Clerk and Recorder's Office</u>

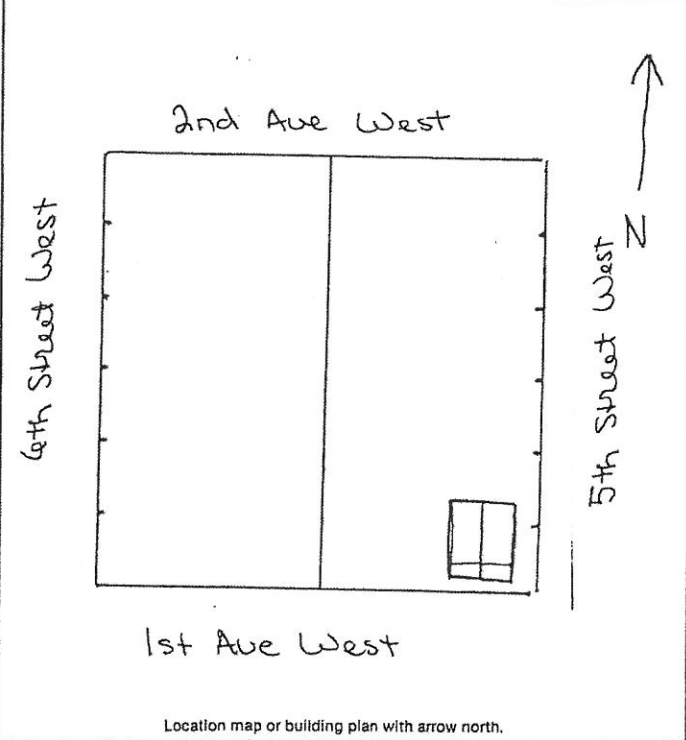
Roll # <u>B3</u> Frame # <u>14</u>

A one-story, wood-frame, square-shaped commercial structure with flat roof, beveled siding with end boards, concrete foundation (where visible). West side of building has stepped sides. East section of building was added later. Front of building has large canopy supported by 4x4 and beams. Front entryway is recessed. Door is wood with panels and light, with overhead panel (transom) and side lights. Front windows are fixed, multipane with wood surround trim and sills. Side garage addition has wood frame, sliding wood doors with panels and lights. Rear of building has interior chimney.

This old gasoline station is located along a major highway into town, near other commercial buildings. It possesses integrity of location, design, and material. Later addition appears to have been made during historical periods but does not detract from integrity of the structure.
