MONTANA HISTORICAL AND ARCHITECTURAL INVENTORY

Legal Description: **Block 2, Lot 9, Park Addition**

Address: **110 6th Street West**

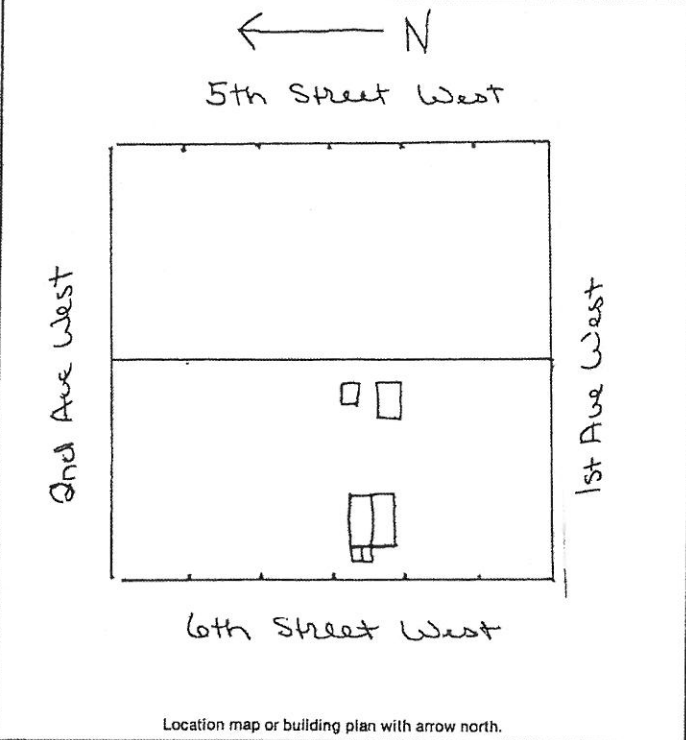
Roll # **B3** Frame # **17**

A one-story, wood-frame rectangular residence with layered gable roof, clapboard and wood shingle siding, and concrete foundation. Roof has interior brick chimney, galvanized metal ridge with front, ball-shaped ornamentation, and composition shingles. Extending front eaves have fascia, purlins and diagonal braces. Windows are wood-frame, double-hung 1/1 (some 9/1) with side wood trim, and corner beams in front, with continuous sills and molding. Building had rear, hip roof extension, with similar material and workmanship, part of which was remodeled in 1952. A wood-frame garage with gable roof with ball shaped ornamentation at end of gable, wood shingles on gable wall is located at rear of property. Garage has horizontal wood siding with stucco finish, wood-frame garage doors with horizontal planks. Small wood-frame, gable roof shed with beveled siding and wood shingles also is located at rear of property.

This residence is located in a block with residences of similar size and age. It was moved to the present site in 1940, so is close to being a historical part of the neighborhood. It has integrity of design, materials workmanship. Small addition at rear of building does not detract from basic integrity of building.
