MONTANA HISTORICAL AND ARCHITECTURAL INVENTORY

Address: 408 Seventh Street West

Original Use: Garage

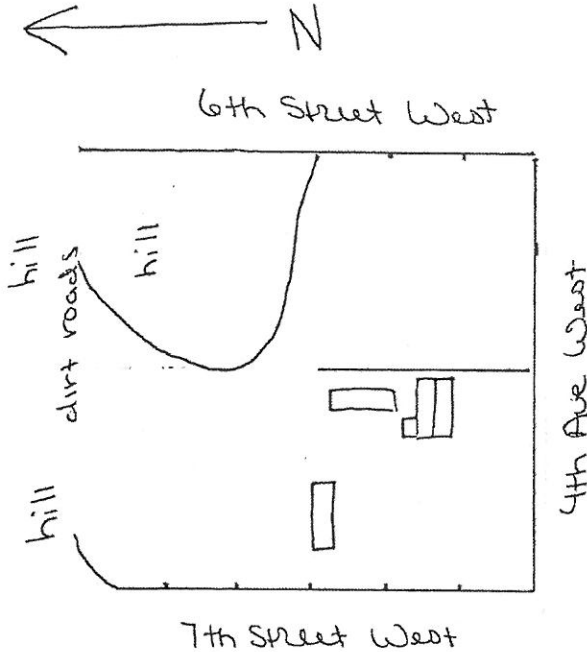
Roll # A13 Frame # 13

This tall one-story wood frame rectangular garage has gable roof and a low shed roof attachment to the north. Other features include wood roof shingles, beveled edge wood siding with corner boards, casement hung bevel edged wood garage doors, 2/2 double-hung south windows and no visible foundation. There is a new cement block exterior chimney.

This garage, flooded out in Klein, is now located in a working class neighborhood of mixed old and remodeled buildings. Moving has caused loss of integrity of location, but the building still retains good integrity of materials, design, and craftsmanship.
