# MONTANA HISTORICAL AND ARCHITECTURAL INVENTORY

Legal Description: Block 3, Parcel J, Park Addition

Address: Fifth Street West

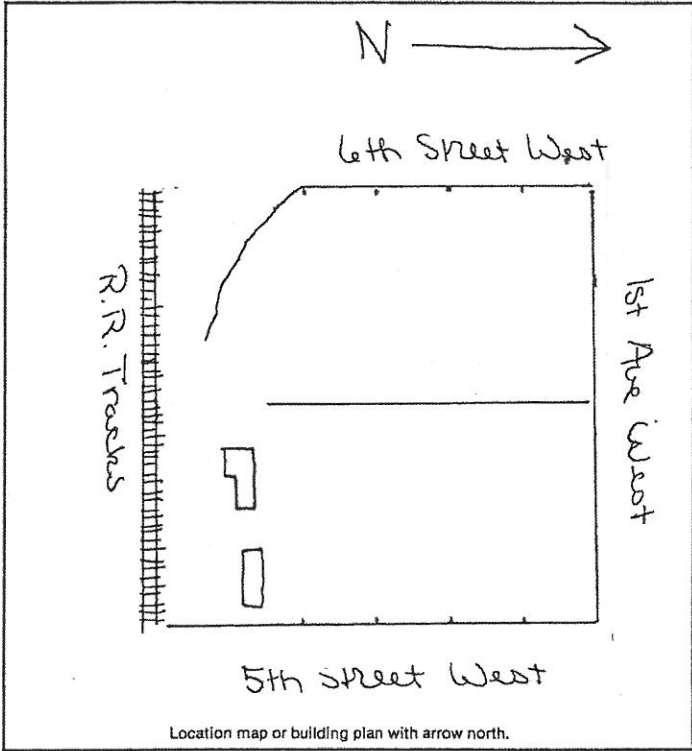
Roll # B3 Frame # 6

A one story rectangular log cabin with gently sloping corrugated metal roof and log foundation. Cabin has eaved and beam rafters, notched joints, mortar chinking, wood-frame casement windows and wood-frame paneled door and interior chimney. A breeze way joins the cabin to a square wood-frame shed with shed roof and wood shingles vertical board and bottom siding, eaves with rafters, wood-frame, boarded up windows, some with exterior hinges and wood-frame paneled door and large entry doors with exterior metal hinges. The cabin is not on the 1920 Sanborn map and may have been moved to the location.

A mobile home is located in the front of the property.

The log building is a contributing structure.
