MONTANA HISTORICAL AND ARCHITECTURAL INVENTORY | Site

Onc "			
Legal Description:_	gal Description: Block 1 Lots 2%3 Roundup First Addition				1	
Address:	619 Fourth Street East			No.	<u> </u>	
Qwnership: name:_	Thomas Hazelton				,	
private address:	619 Fourth Street East Roundup, Mt.			Roll # A13	Frame # 19	
	N> 3rd Street Chat	٠.	Historic Name: Common Name: Date of Construction: Architect:	1980		estimated
1

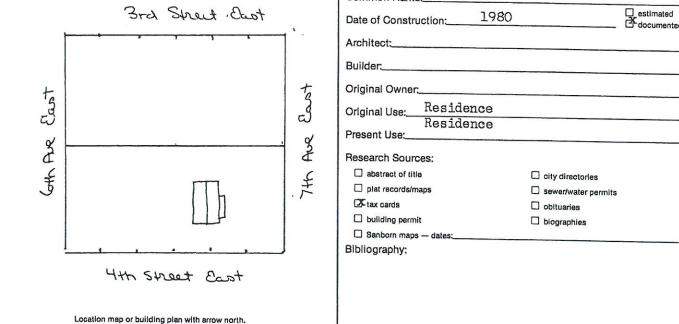
This rectangular one story wood frame residence has a slight pitch gable roof and a shed roof open porch and enclosed entry .- Other features include interior and exterior metal stove pipe chimneys, asphalt and roofing, decorative wood siding with metal cornerboards, assorted aluminium frame windows, decorative wood slate shutters, and a cement foundation.

This is a neutral structure.

INTEGRITY: Assess the degree to which the structure/site, and surrounding area accurately convey the historical associations of the property. This house is located on the edge of town, near a cement company and trucking yard, facing open prairie, This house has been added to with such an assortment of additions, windows, roof materials that despite it's unusial two story clipped gable roof original structure, it has lost integrity of design and materials.
